# Manhole Inspection Summary

Manhole # S35C\_\_010MH

Insp Date: **11/14/08 11:40 AM**

**Location** Address: **312 N Charles St**

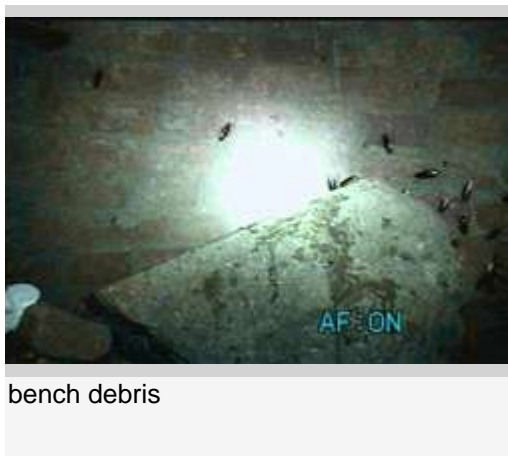
Defect 3

Condition: ☐ Sound ☐ Cracked ☐ Root Intrusion ☐ Deteriorated ☐ Leaks ☒ **Debris**

bench debris

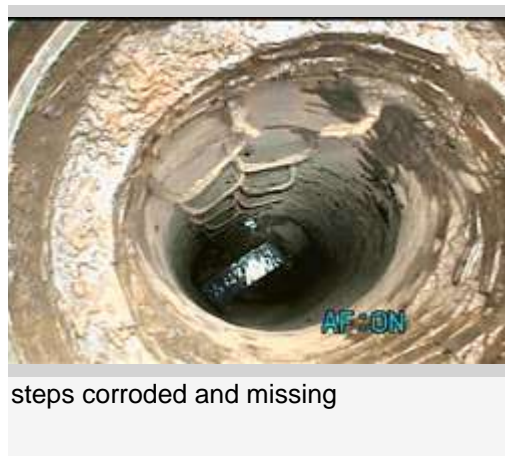
Defect 2

**Steps** Count: **13** Missing: **2** ☒ **Corroded**

steps corroded and missing

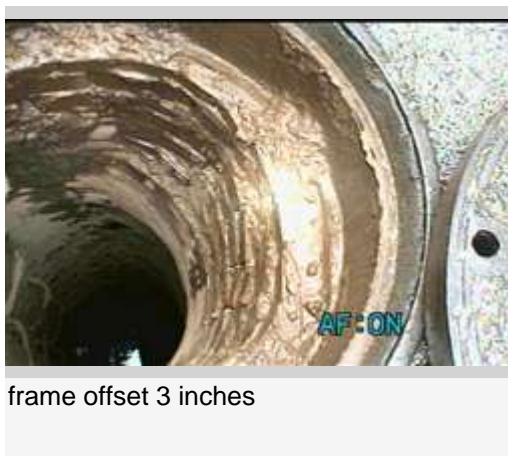
Defect 1

**Frame** Offset: **3** (in.) Condition: ☒ Sound ☐ Cracked ☐ Leaks

frame offset 3 inches

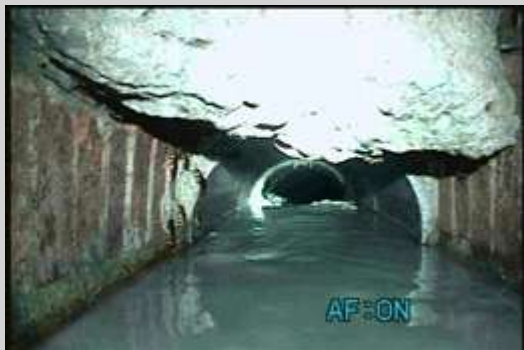
12 O'Clock Outflow

10 in. Circular Gravity Sewer  
Pipe Out @ 12 O'Clock

Pipe Material: **Clay** ☐ Pipe Lined

Invert Depth: 17.10 (ft.) Flow Characteristics: **Slow**

Infiltration: **None** Pipe Seal Cond: **Unknown**

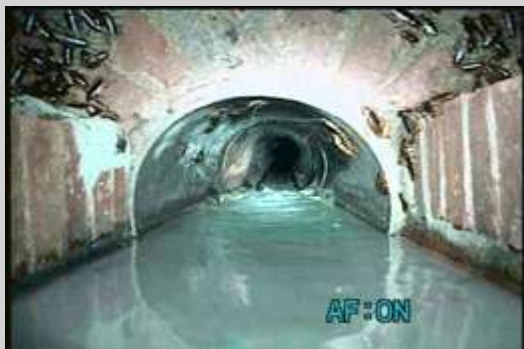
6 O'Clock Inflow

10 in. Circular Gravity Sewer  
Pipe In @ 6 O'Clock

Pipe Material: **Clay** ☐ Pipe Lined

Invert Depth: 17.90 (ft.) Flow Characteristics: **Slow**

Infiltration: **None** Pipe Seal Cond: **Unknown**
